DANGER ON OUR HIGHWAYS: GUARDRAILS THAT MAIM AND KILL

BY Kent Emison & Michael Serra

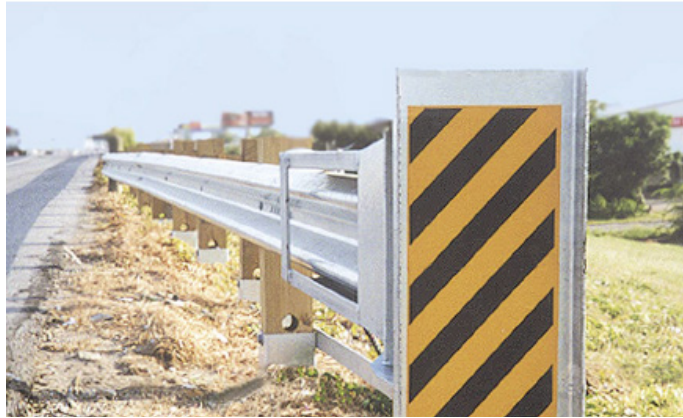
In the late 1980s, energy-absorbing end terminals were developed to absorb the impact from a vehicle and allow it to “ride down” the crash without piercing or

overturning the vehicle. One of the most popular energy-absorbing end terminals was the Trinity ET-2000, which had reasonably good results. However, Trinity chose to modify the end terminal to increase profits, which had drastic and deadly consequences.

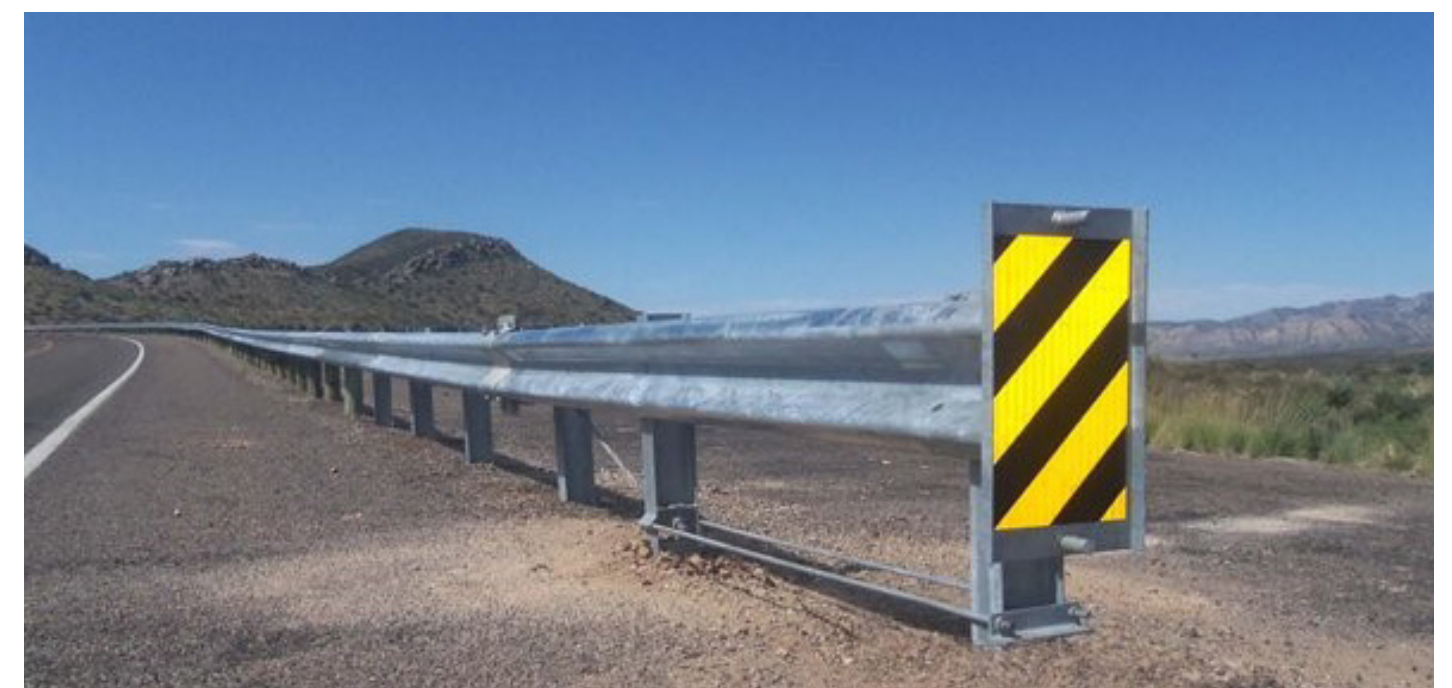
The Transportation Research Board is currently conducting an ongoing in-service study evaluation on the performance of guardrail end terminals. Since May 2016, it has been collecting information from California, Massachusetts, Missouri and Pennsylvania. As of July 31, 2017, the study identified 47 crashes with X-Lite terminals, resulting in 32 property damage incidents; eight minor injury crashes;

four serious injury crashes; and three fatalities. However, a survey of news stories and lawsuits indicates there are 17 incidents in the U.S. since 2016 that resulted in a fatality or serious injury.

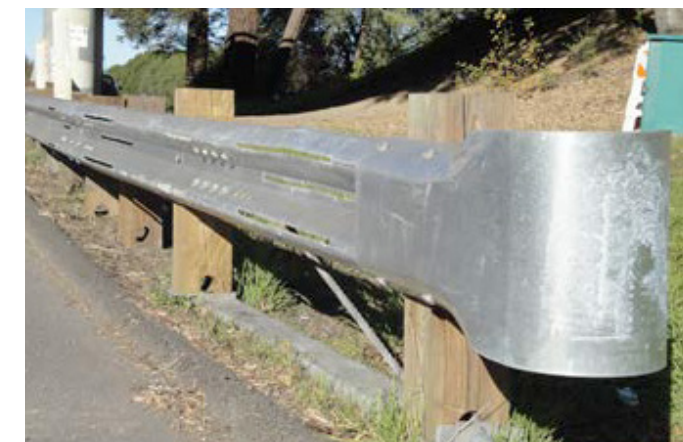
SRT Guardrails

The SRT end terminals were developed in the 1990s. SRTs are “slotted rail terminals” and differ from the end terminals discussed above in that they are non-energy absorbing. The SRT design concept involved cutting longitudinal slots in the W-beam rails of the terminal system. This design reduced the buckling strength of the rails in the event of an end-on collision. The patent explains that the reduced buckling strength of the slotted W-beam allows for controlled buckling of the W-beam rail and minimizes some dangers of other end terminals. To function properly, the slot guards must be placed at the downstream end of the slots and away from the di-rection of traffic; however, the rails are manufactured with the same hole pat-terns on the rail ends for assembly, which leads to the guardrail being assembled improperly.
