# Defective Guardrails on Our NATION'S ROADS

By Adam Graves & David Brose

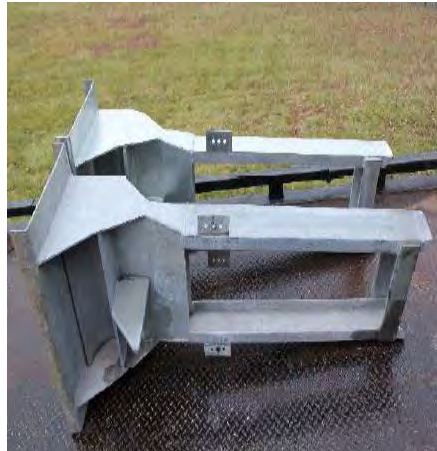
Side view of 5-inch ET-Plus (front) and 4-inch ET-Plus (back). *Photo courtesy Langdon & Emison.*

In 2005, Trinity secretly began working on significant modifications to the ET-Plus by reducing the feeder chute’s width from 5 inches to 4 inches, reducing the feeder chute’s height from 15.375 inches to 14.875 inches, and decreasing the weight of the end terminal by 8.1 pounds. The FHWA and most state departments of transportation (DOT) require that any design changes be

Be sure you know how to distinguish the defective ET-Plus end terminal from other guardrail models. The ET-Plus guardrails have a distinctive rectangular design, while Trinity’s previous (and safer) design, the ET-2000, used a square end terminal. To distinguish between the 5-inch and 4-inch ET-Plus model, you can measure the width of the beam and the height of the guide channel.

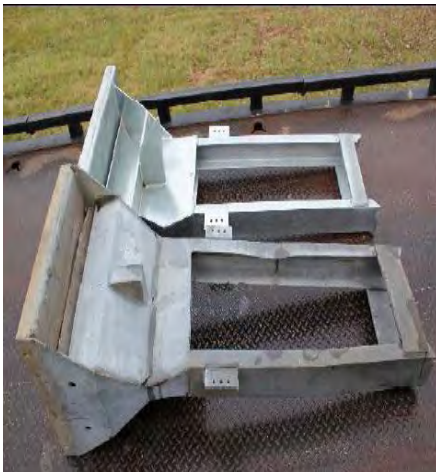
Side view of Trinity ET-2000 (front) and Trinity ET-Plus (back). *Photo courtesy Langdon & Emison.*

**2. The End Terminal Head:** As can be seen in the photo below, there is a significant difference between the terminal head on the original ET-2000 and both models of the ET-Plus. The original ET-2000 has a square 20-inch head, while both ET-Plus models have a much narrower rectangular design. In addition, the original ET-2000 has an anchorage lip on all four sides of the head, while both ET-Plus models only have anchorage lips on the sides. How does this create a danger? First, the greatly narrowed head of the ET-Plus models provides far less stability for the end terminal when it is in contact with the vehicle. Second, during a collision, the anchorage lips prevent the terminal head from slipping off of the vehicle. In the original ET-2000, the anchorage lips were on all four sides of the terminal head, thus preventing slippage in all directions. On both models of the ET-Plus, the anchorage lips on the sides help prevent slippage sideways; however, due to the lack of anchorage lips on the top and bottom of the terminal head, there is nothing to prevent the terminal head from slipping below or over the top of a striking vehicle.

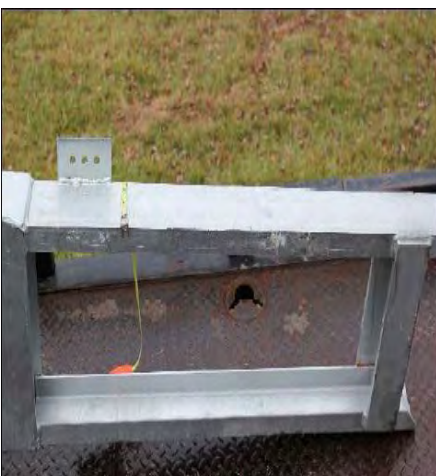
ET-Plus 4-inch guide channel. *Photo courtesy Langdon & Emison.*

The dimensional changes affect how the rail collapses on impact. The rail is supposed to turn away from the striking vehicle as a flat ribbon. Instead, the rail locks up inside the feeder chute and folds back, forming a spear that can slice right through a car or truck. The resulting injuries to occupants are horrendous.<sup>2</sup>
